Intel® High Definition Audio Specification Document Change Notification

Change Identification: **DCN No: HDA001-A**
Document Revision: Intel® High Definition Audio 1.0

Title: Clarification to Interrupt Status

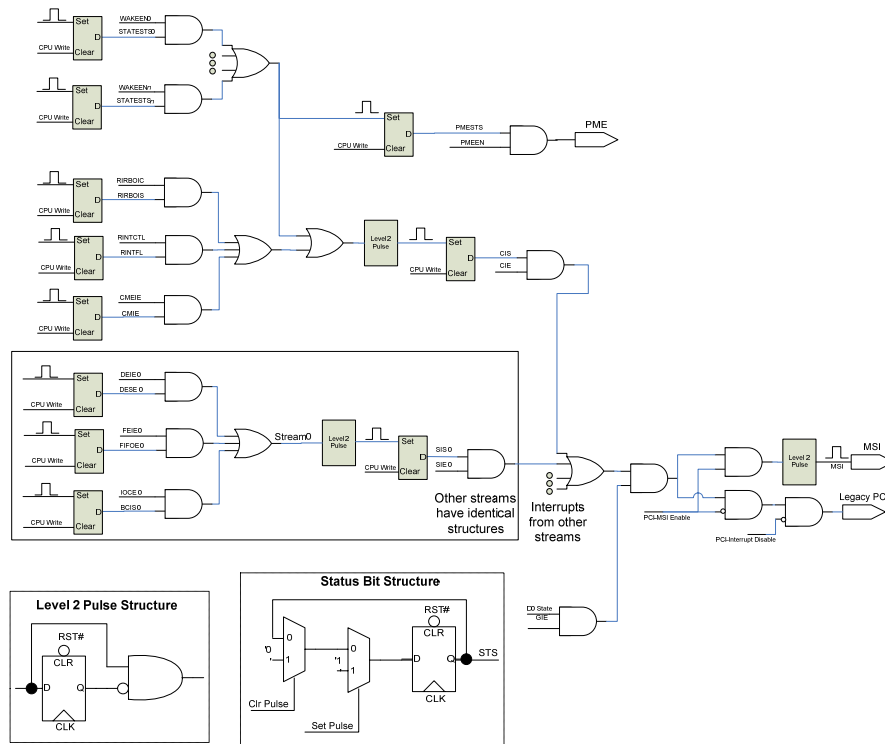
Section 3.5 of the Intel® High Definition specification version 1.0 defines:

The Intel® High Definition Audio specification version 1.0 specifies that Interrupt Status bits CIS and SIS are sticky and written to 1 to clear, but with the known implementations CIS and SIS are an OR of the interrupt condition and can not be cleared by writing a 1. As current implementations differ from the specification the specification is updated to reflect the real world implementations.

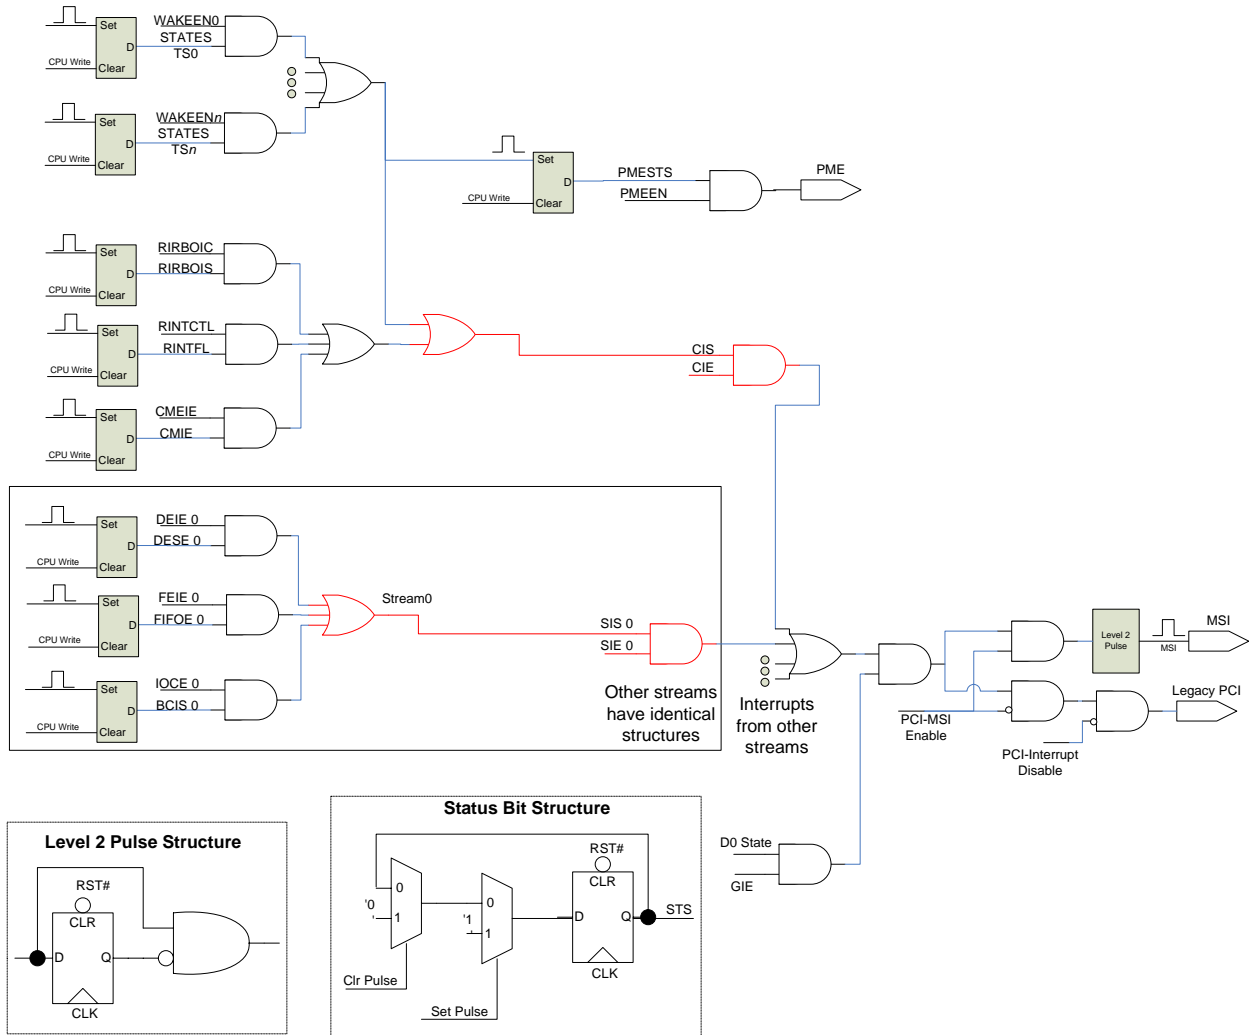
Section 3.5

Error! Reference source not found. is a representation of the interrupt tree to show the logical relationship of various signals. It should not be taken as a literal implementation.
